# Seamless Image Stitching Using the CELENA<sup>®</sup> X High Content Imaging System

- Generating high-resolution panoramic images using the CELENA<sup>®</sup> X High Content Imaging System.

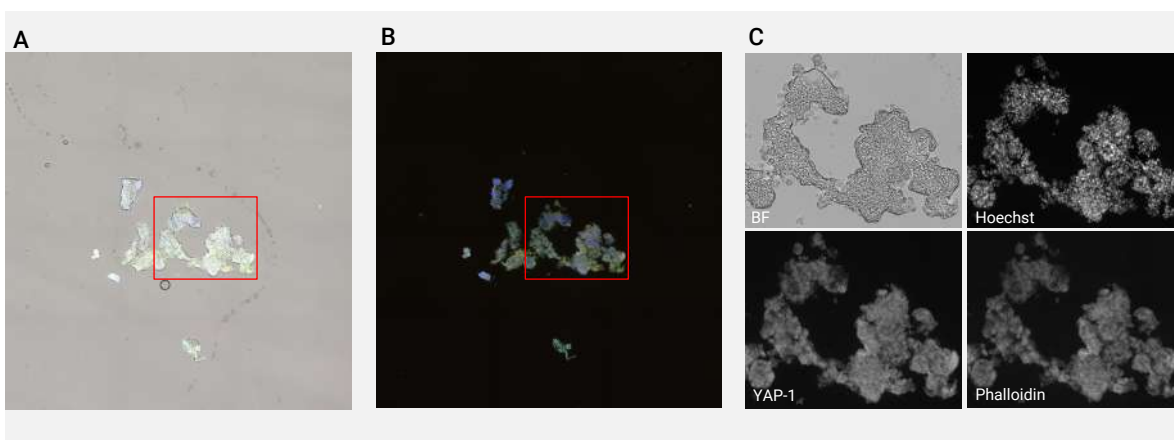
**Figure 4.** The combined image stitching results using all channels with (A) and without (B) BF channel (4464 x 4428 pixels). (C) Multi-channel images obtained from the area marked with the red square.

Organoid culture is a three-dimensional cell culture technique mimicking the physiological conditions like that of organs. Thanks to this property, experiments using organoid culture provide results similar to in vivo experiments. Image stitching is a great way of studying organoid samples which can be prepared by sectioning and using immunofluorescent staining to visualize molecular markers. Multi-channel imaging was conducted on organoid samples and image stitching was performed using the CELENA<sup>®</sup> X High Content Imaging System (Figure 4).
