# Seamless Image Stitching Using the CELENA<sup>®</sup> X High Content Imaging System

- Generating high-resolution panoramic images using the CELENA<sup>®</sup> X High Content Imaging System.

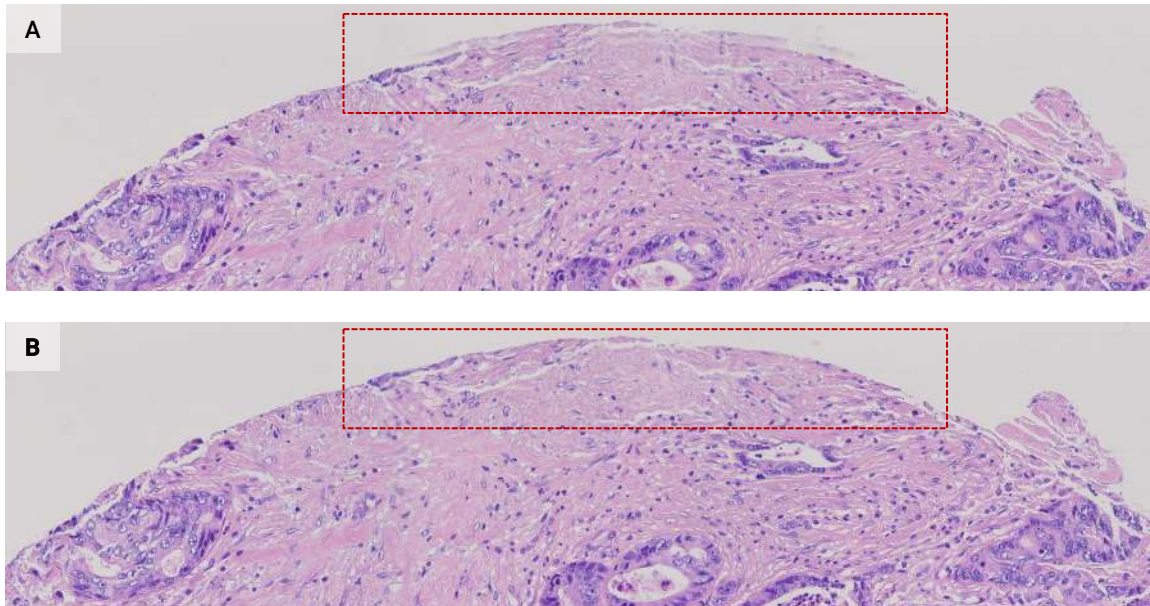
**Figure 1.** (A) The final result of the stitched image shows it was misaligned when using the original image stitching algorithm. (B) The final result of the stitched image shows a seamless image using the advanced proprietary algorithm. (1500 x 375 pixels)

Image stitching algorithm works to pair images based on the similarity of the overall appearance between images. In general, image stitching is performed following the order of how the images are saved. Unfortunately, this strategy can cause unwanted visual artifacts to appear along the image boundaries. This is especially true if there are no distinct characteristics present. This issue is a common problem when using image stitching algorithms (Figure 1A).

We resolved this issue by assembling distinct images first instead of following the order in which the images were saved. In turn, the CELENA<sup>®</sup> X Cell Analyzer software provided seamless image stitching results even with less distinguishable images (obtained from the upper part of the stitched image). (Figure 1B).

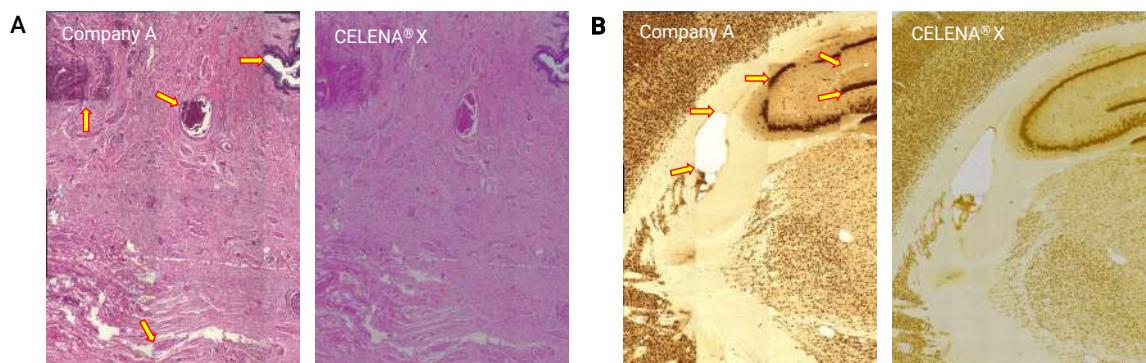
**Figure 2.** (A) Image stitching results using H&E slides: Company A's image results show misalignment and distortion issues versus the result image using the CELENA<sup>®</sup> X Cell Analyzer Software and the seamless image results (301 x 423 pixels). (B) Image stitching results using mouse brain sample: Company A's image results show misalignment and distortion issues versus the result image using the CELENA<sup>®</sup> X Cell Analyzer Software and the seamless image results (471 x 662 pixels).

Image stitching performance was compared between the CELENA<sup>®</sup> X Cell Analyzer software and company A's software. The comparison was made by running the image stitching algorithm with images obtained from the same sample. The stitched image from company A's software had distortion and misalignment errors which made it difficult to accurately understand the overall morphology of each sample. (Figure 2A). Whereas the CELENA<sup>®</sup> X Cell Analyzer software successfully produced a seamless image with no visible errors (Figure 2B).

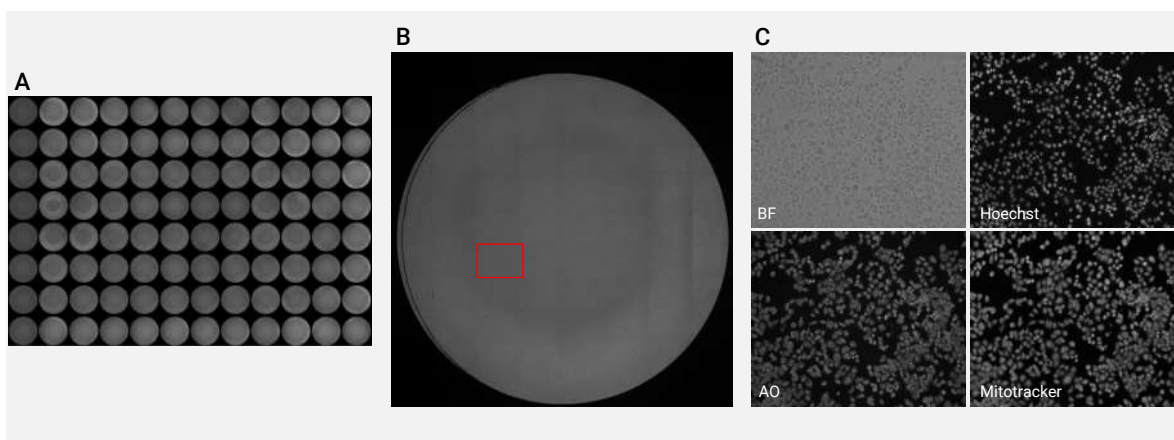
**Figure 3.** (A) The whole 96-well plate image stitching result. (B) The image stitching result from one of 96 wells using BF images (11336 x 11788 pixels). (C) Multi-channel images obtained from the area marked with the red square.

The CELENA<sup>®</sup> X High Content Imaging System is designed to run in vitro scientific experiments. The complete regions of interest on multi-well plates and dishes can be selected and imaged by the CELENA<sup>®</sup> X Cell Analyzer software. With this advantage, the whole-well image stitching was conducted using multi-channel images to show superior image stitching performance (Figure 3).

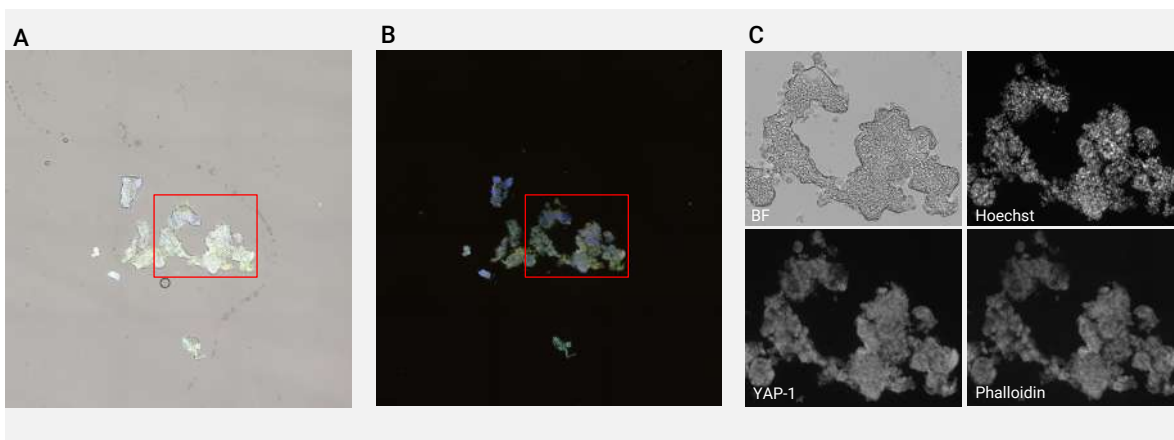
**Figure 4.** The combined image stitching results using all channels with (A) and without (B) BF channel (4464 x 4428 pixels). (C) Multi-channel images obtained from the area marked with the red square.

Organoid culture is a three-dimensional cell culture technique mimicking the physiological conditions like that of organs. Thanks to this property, experiments using organoid culture provide results similar to in vivo experiments. Image stitching is a great way of studying organoid samples which can be prepared by sectioning and using immunofluorescent staining to visualize molecular markers. Multi-channel imaging was conducted on organoid samples and image stitching was performed using the CELENA<sup>®</sup> X High Content Imaging System (Figure 4).
